Egyptian Theatre

229 South Broadway Coos Bay, Oregon

Facilities Improvement Evaluation Report

December, 2010

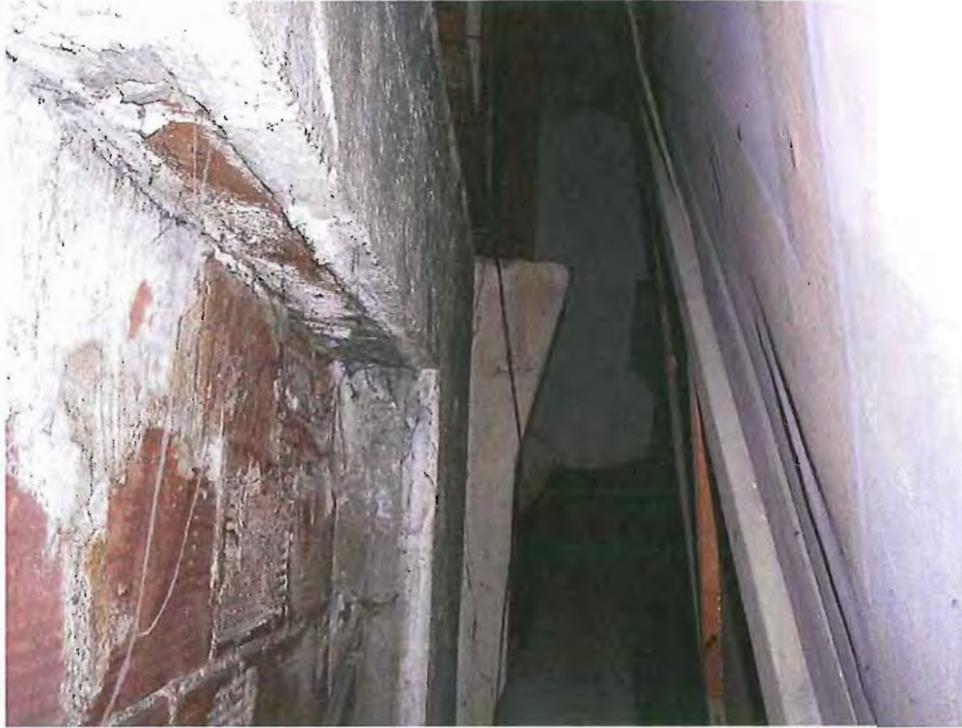
Figure 3.7 – Typical Concrete Pilaster

The roof is currently supported by a cast-in-place 12" thick concrete wall with 16" thick x 28" wide concrete pilasters at each truss (*Figure 3.7*). It has been observed that the trusses at each end of the building have been moved off their original pilaster bearings (Gridline '2.4' and '7.5') and are currently resting on a 4" ledge supported by the 12" thick wall only (*Figure 3.8*). It is our understanding the trusses were moved to make room of the fly loft and projection room construction when converted to a theatre in 1925. Unfortunately this condition was not properly addressed at the time of construction and has caused failure of connections and other roof framing members (*Figure 3.9*). Supplemental support for the relocated trusses and unsupported roof framing has been illustrated in the framing plan provided for reference (*Sheet S2.1*). Several large cracks have been identified along the exterior concrete walls at gridline '2.4' that appear to have been caused by differential settlement of the foundation (*Figure 3.10*).

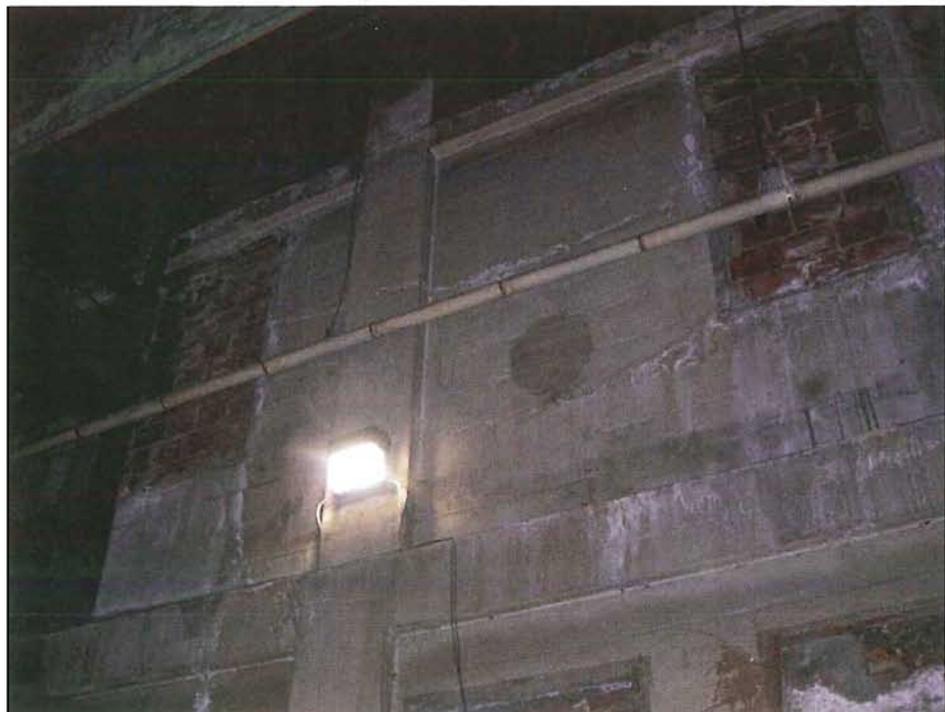
Figure 5.5 – Fly Loft Wall Construction

truss and four ply beams at the back wall (*Figure 5.5*). Unfortunately, this condition was not properly addressed at the time of construction and has caused failure of connections, roof framing, floor framing members on every level, and the foundation system (*Figure 5.6*). A geotechnical analysis was performed to determine cause of settlement (*See Appendix A*).

Rather than reinforce the existing concrete walls of the fly loft, we recommend removing the rear wall completely and the demolition of the side walls down the original main roof elevation, just above the adjacent building roof elevations. This will allow for crucial access to the foundation systems and interior framing deficiencies stated above. The walls will be replaced with factory-cast full height concrete panels (*Sheet S3.1*). The concrete panels will extend across the separation line between the fly loft and main roof providing a lateral force resisting system at the vertical irregularity. This work will also correct the disconnect caused by the settlement of the existing fly loft construction.

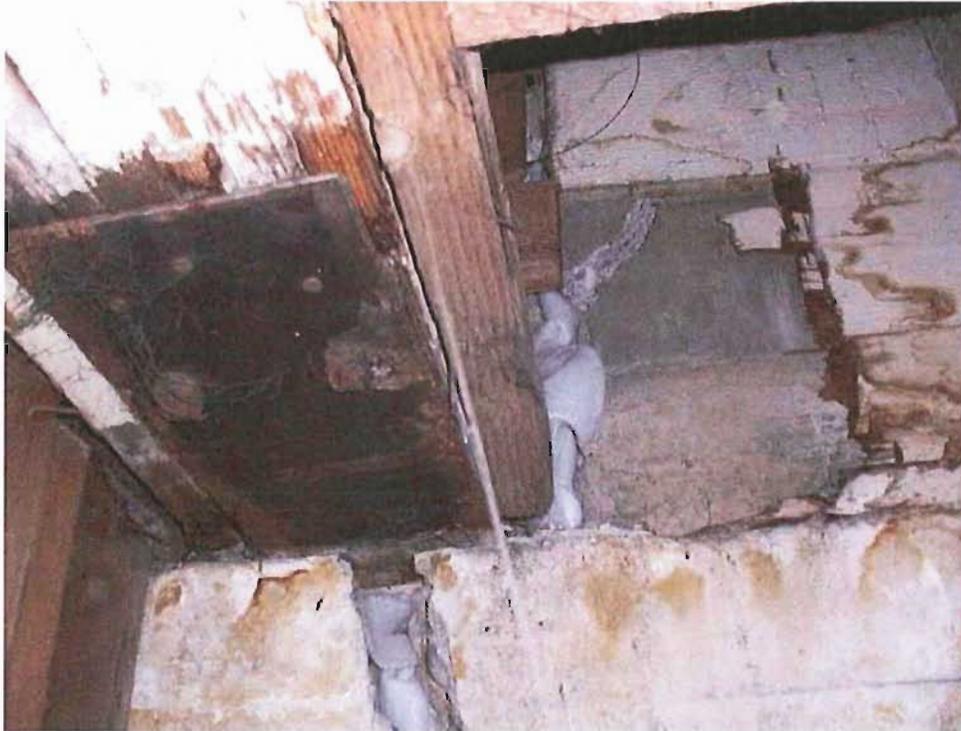
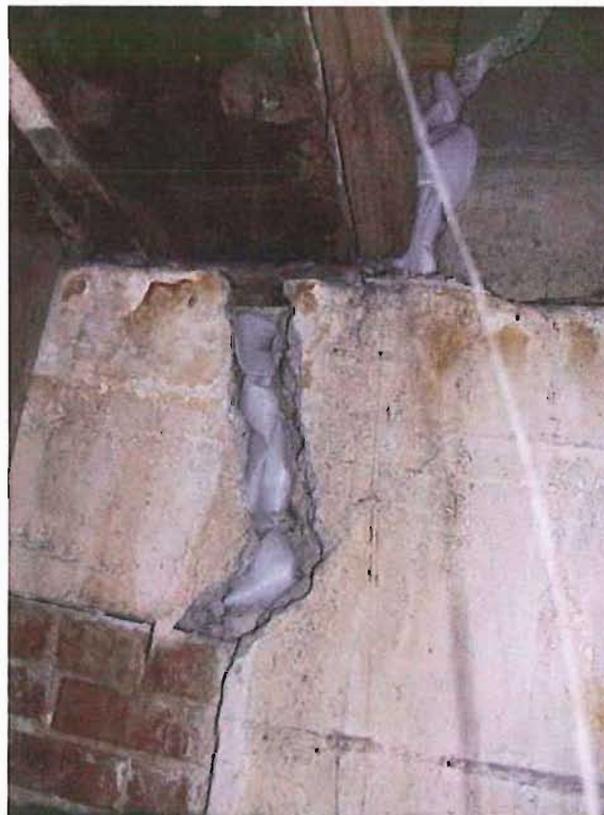
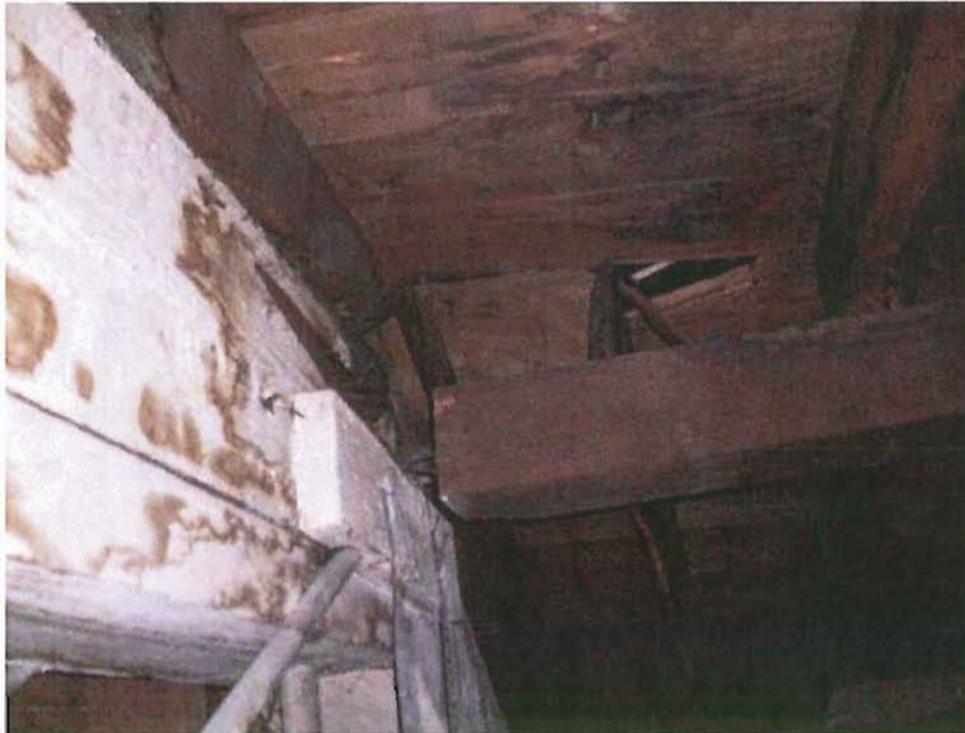
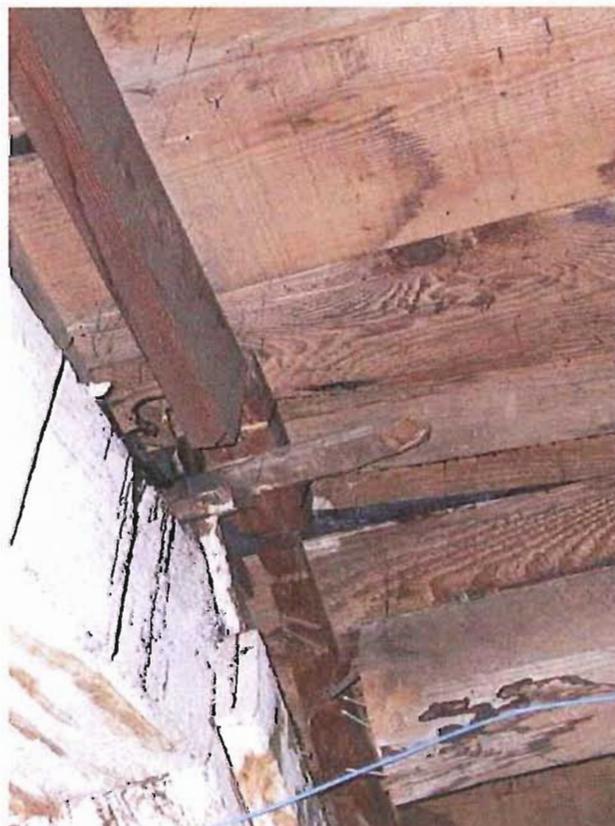
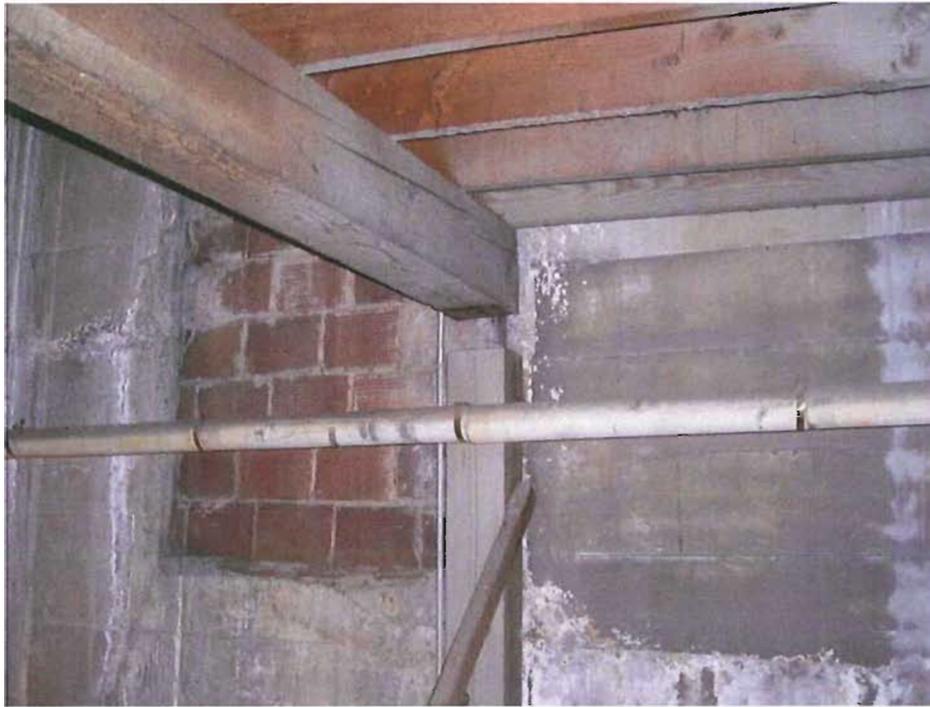
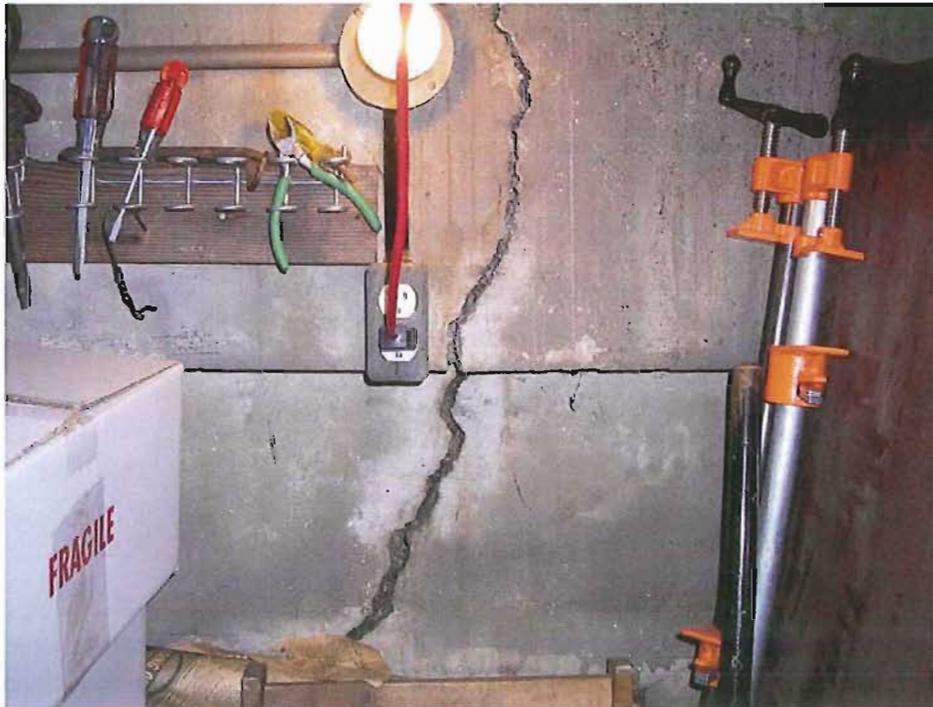
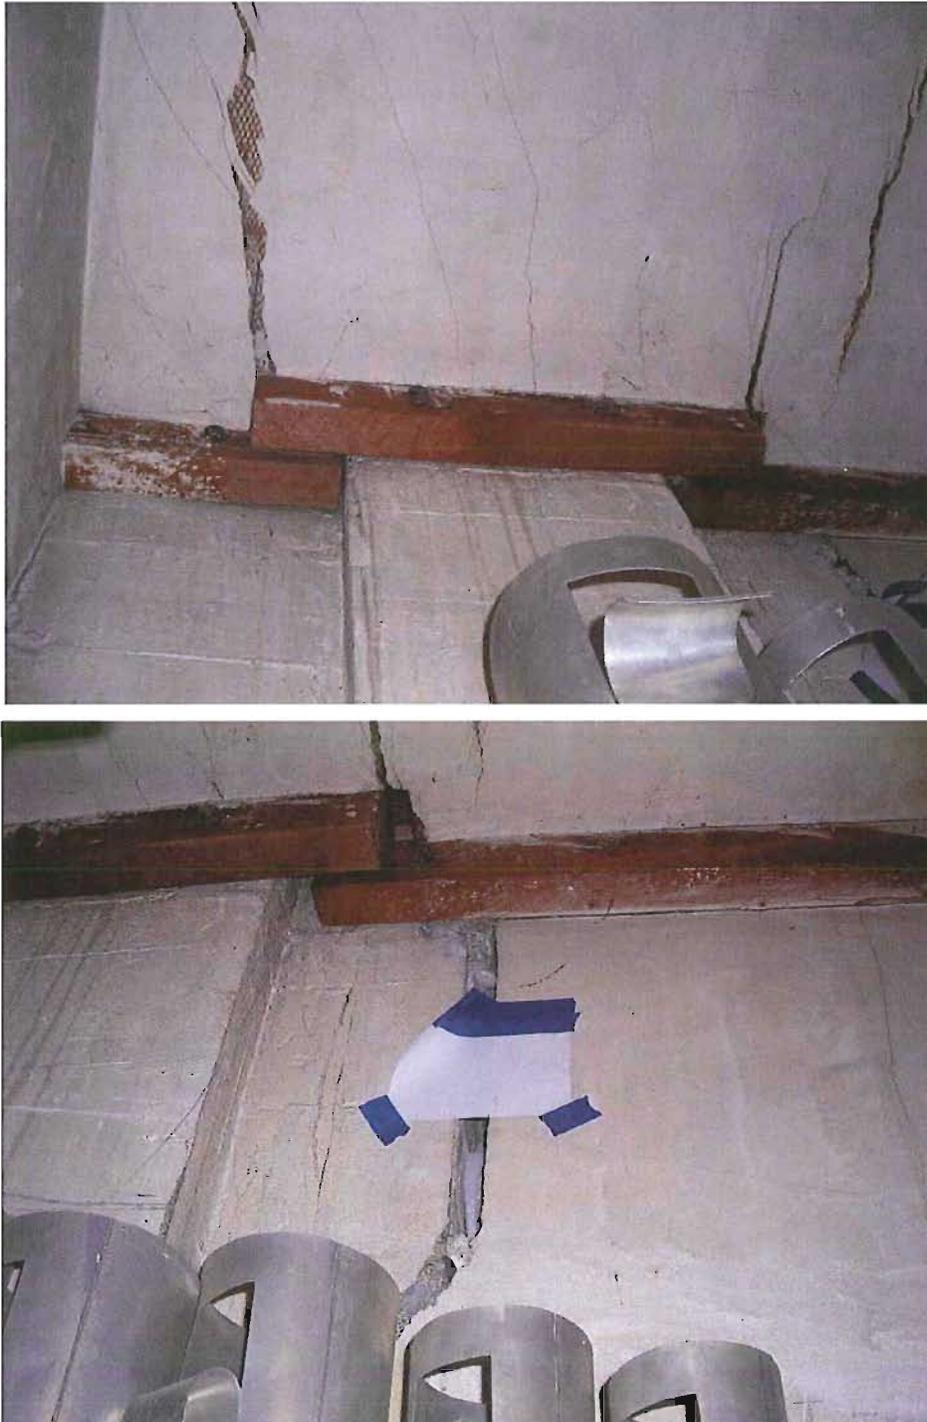
Figure 5.6 – Fly Loft Wall Settlement Damage

Supplemental support for these systems would be very extensive and limited to the space available. Foundation solutions would be hindered and upgrades to the theatrical equipment would be difficult to accomplish. Several large cracks have been identified along the exterior concrete walls that appear to have been caused by differential settlement of the foundation. A 3-D scan survey of the entire building has been performed to determine the level of settlement experienced by the fly loft. Most of the settlement of the fly loft has occurred along the back wall and measures approximately 7" to 9" vertically and approximately 7" to 9" horizontally outward at the top of the wall (*Figure 2.3*). Essentially, the wall is leaning away from the rest of the building pulling the side walls and framing with it. The separation is occurring between the upper fly loft wall and lower main roof and down to the foundation (Gridline '2.4').

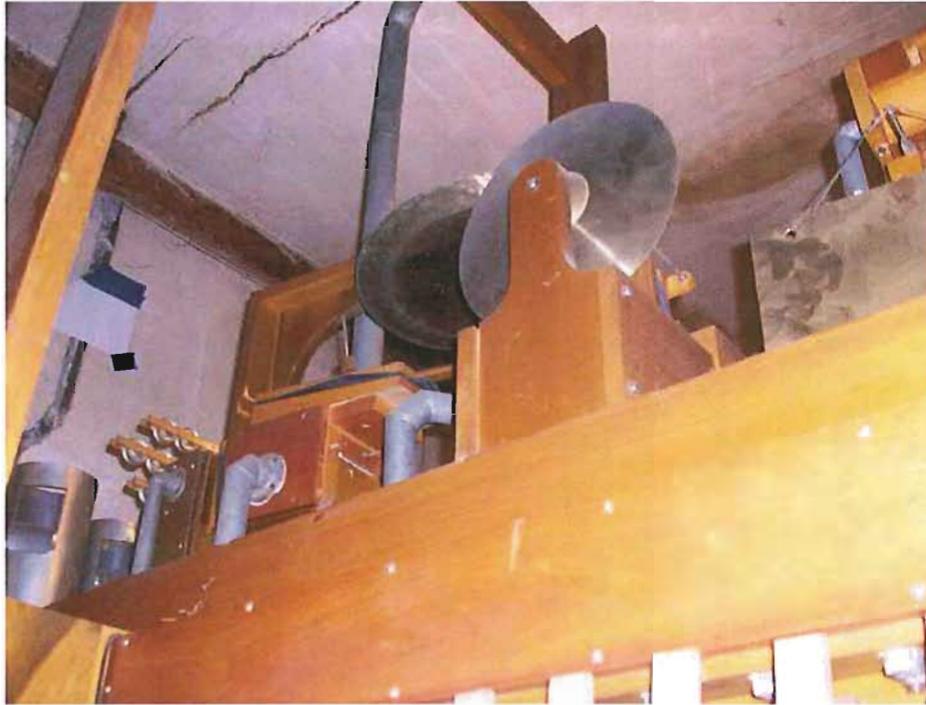
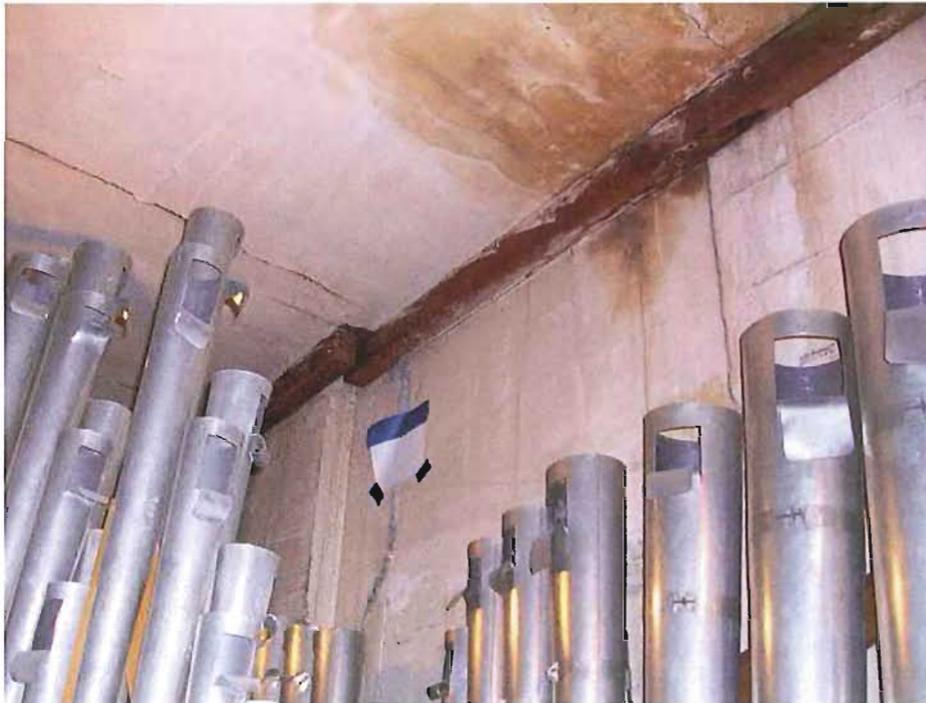
Figure 5.7 – Organ Room Settlement Damage

It is our understanding the settlement has worsened over the past 30 years according to the gentlemen tasked with the job of maintaining the organ instruments. The organ instruments rooms are located at the line of separation described above (*Sheet A1.3*). This presents an interesting challenge to the project. The organ and its instruments are currently fully operational and are very valuable to the theatre's historical value (*Appendix D*). The settlement of the fly loft has caused the floor in the instrument rooms to be unlevel putting the instruments in jeopardy of damage and improper function (*Figure 5.7*). The goal of this project would be to provide a safe and level space to continue the use of the organ instruments.

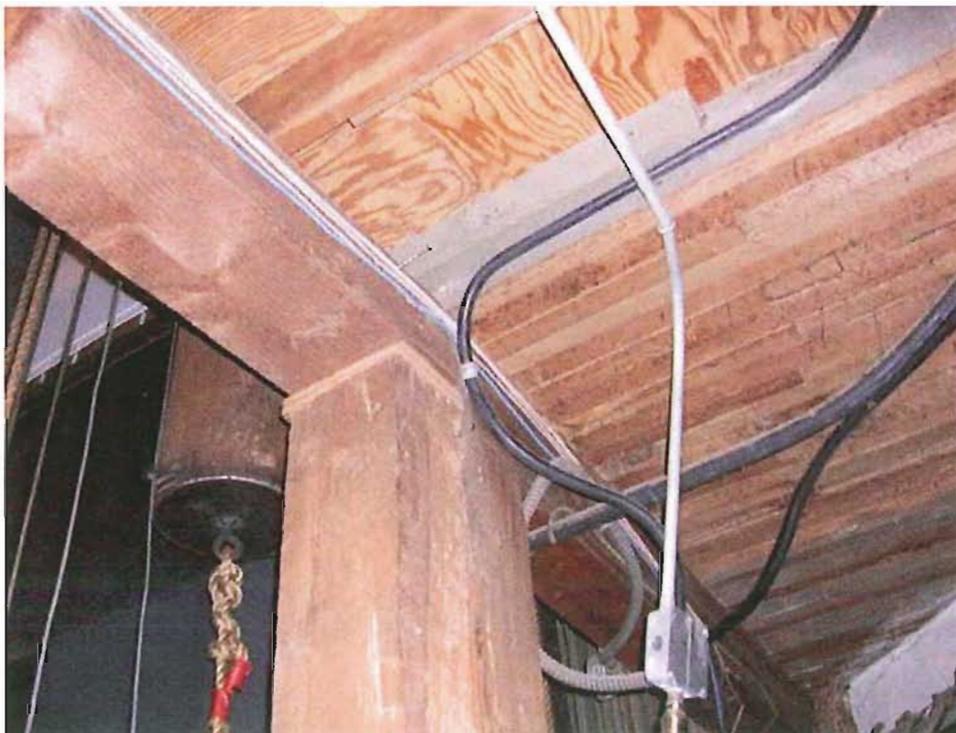
Figure 6.1 – Electrical System

The existing electrical system in the theatre has been modified and added to several times over the years. Much of the work is undocumented and appears to be difficult to evaluate (Figure 6.1). However, according to Cedar Electric, who had recently worked in the building, the following is a summary of the current condition:

- The electrical system has never had a major upgrade. The conductors are primarily rubber insulated with cloth covering. The conduits are painted black iron. Many are broken and not continuous. Some of the feeders are open spliced.

- The lighting is extremely difficult to maintain. Some areas require a 40 foot extension ladder to replace Edison base light bulbs. Most areas show signs of overheating and deterioration. Nearly all the lighting is extremely inefficient and, as mentioned, has high operational costs. It is also inadequate as to required light levels and theater visibility.

- Emergency Egress Lighting systems are minimal and inadequate. There is not any fire alarm or notification system. There is not any security system.

With the level of work being performed throughout the building and the potential fire danger of the existing system, it is our recommendation the primary electrical system is completely replaced during this phase of the project. The following is a summary of the recommended upgrades and improvements:
