Egyptian Theatre

229 South Broadway Coos Bay, Oregon

Facilities Improvement Evaluation Report

December, 2010

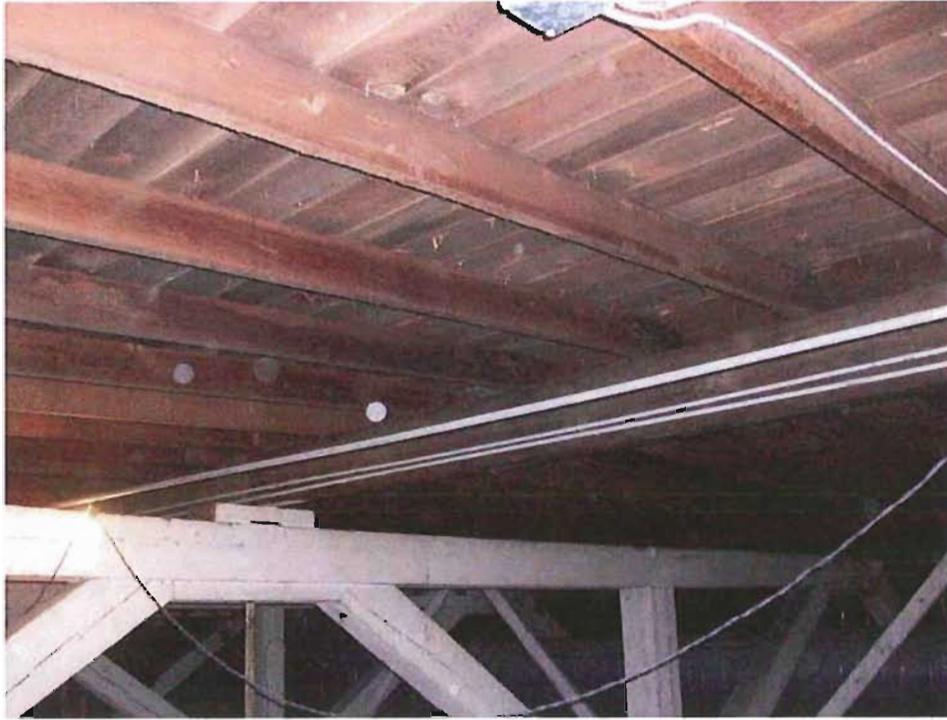
Figure 3.1 – Roof Framing

The primary roof framing consists of heavy timber trusses spaced at 17' on-center (or less) supporting 4x6 rough sawn beams spaced at 14' o.c. The secondary roof framing consists of 2x6 rafters at 24" o.c. with 1x8 straight sheathing (*Figure 3.1*). We performed several cores through the roof layers and discovered that the roof had been re-sheathed with 7/16" OSB over the original 3/16" thick asphaltic built-up roofing. The top layer consists of 1/4" thick asphaltic built-up roofing (*Figure 3.2*). The ceiling construction consists of 2x8 rough sawn joists at 16" o.c. supported by the heavy timber truss bottom chords (*Figure 3.3*). All of the framing is fastened together with 8d, 10d, and 20d common nails with the exception of the heavy timber trusses. The truss connections consist of 1/4" steel plates and through bolts (*Figure 3.4*).

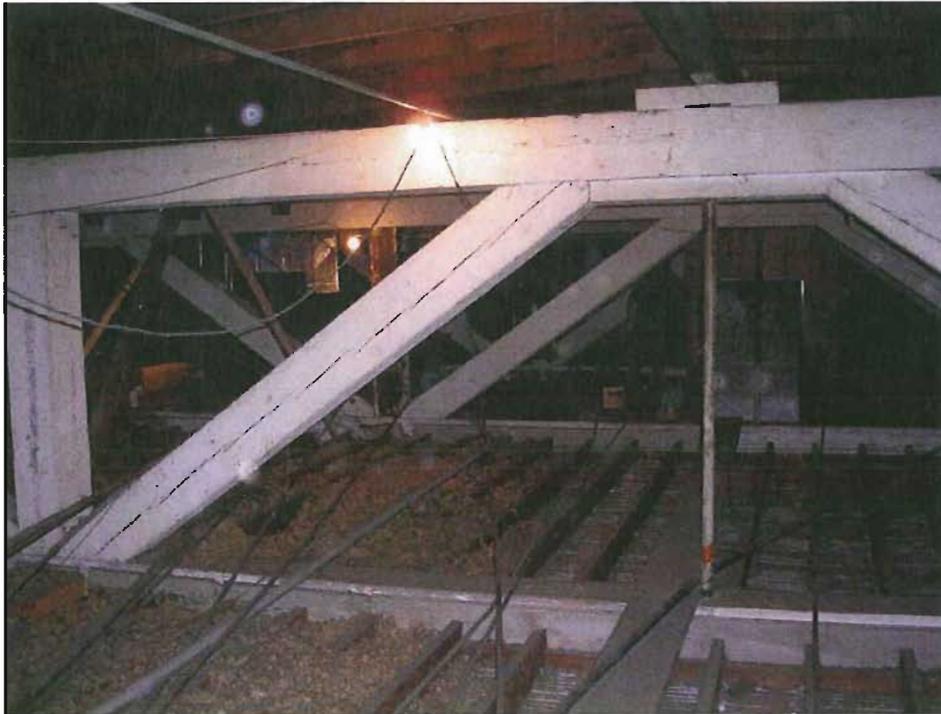
Figure 3.5 – Truss Top Chord Support

The trusses were analyzed using computer modeling software (RISA) to accurately determine a safe performance level and measure an acceptable deflection limit. The trusses were found to be performing within current codes standards for load capacity and deflection. However, it was determined the top chord of the truss was inadequately supported laterally (*Figure 3.5*). The remaining roof framing elements were also analyzed and determined to be inadequate for load capacity during a code level event (*Figure 3.6*).

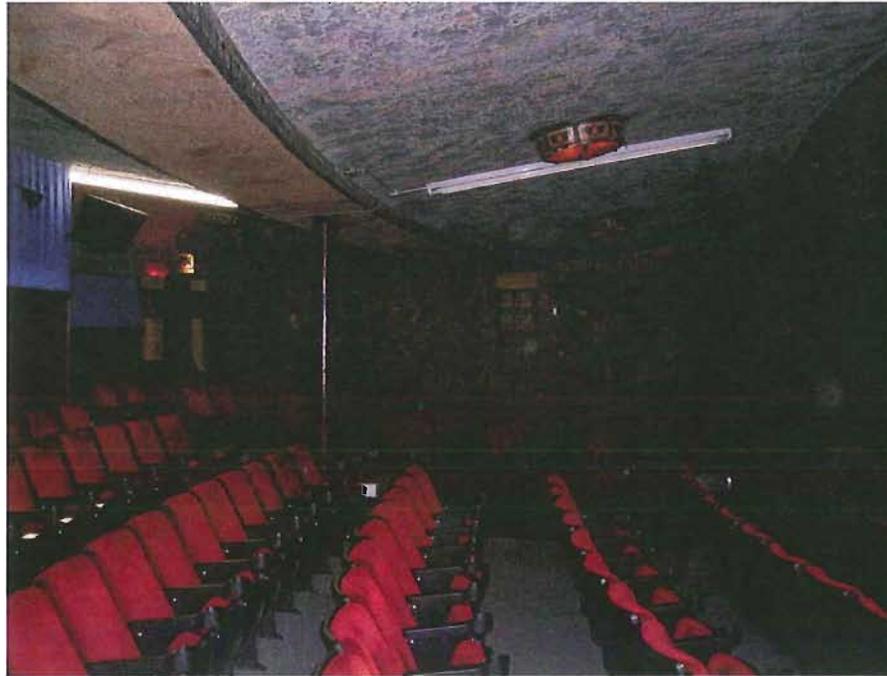
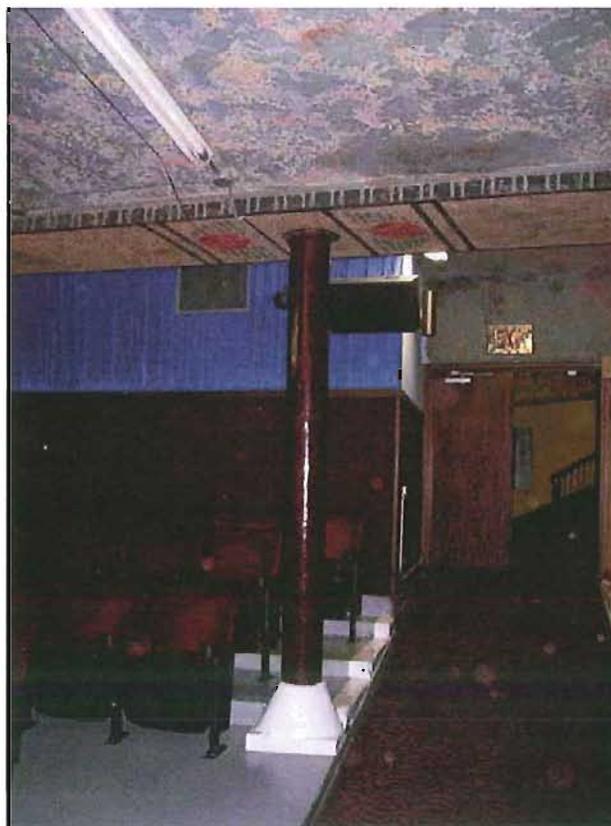
Figure 4.1 – Mezzanine Support Column

The primary mezzanine framing consists of cantilevered timber trusses spaced at 12" on-center supported by a W24x55 steel beam spanning 23' from exterior wall to interior steel 6" dia. columns, and 23' between interior columns (*Figure 4.1*). The trusses consist of 3x12 rough sawn members for top and (2) 2x14 bottom chords/webs. The trusses are over-framed with rough sawn 2x material to create the stepped stadium seating profile (*Figure 4.2*). We cut through the existing wall and ceiling finishes at several locations to provide inspection access to the framing. The remaining floor and ceiling framing for the projection room and lobby consists of 2x rough sawn framing supported by heavy timber rough sawn beams and posts. All of the framing is fastened together with 8d, 10d, and 20d common nails with the exception of the trusses. The truss connections consist of through bolts.

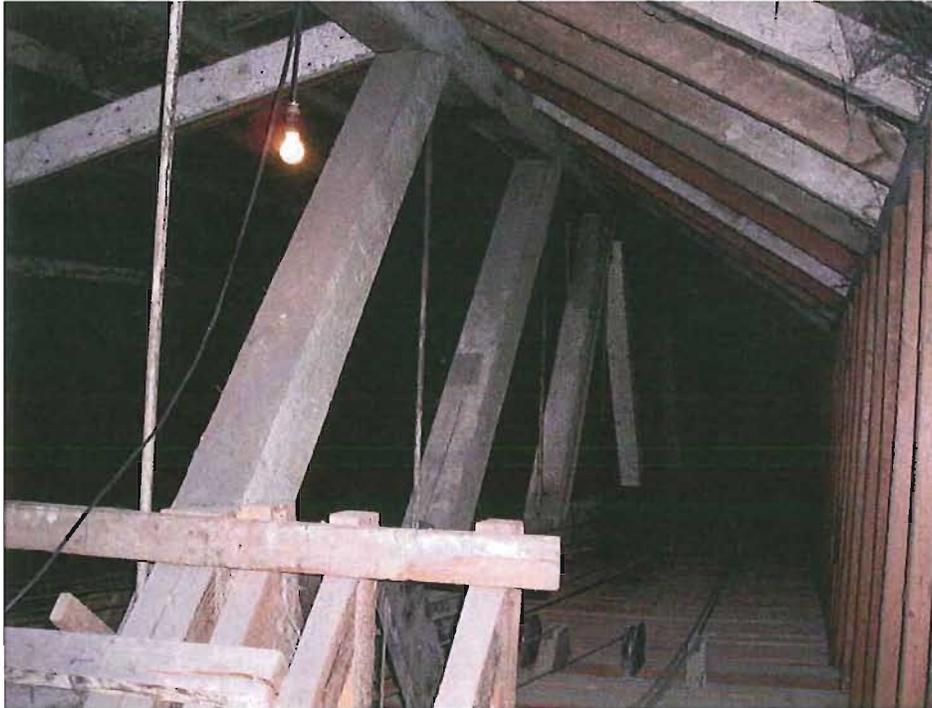
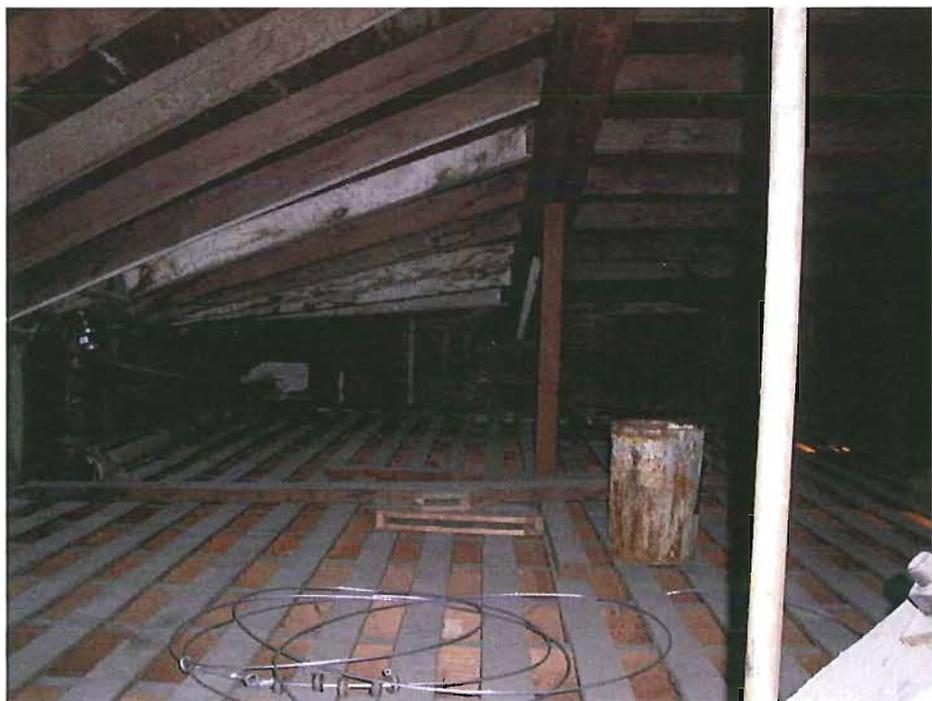
Figure 5.1 – Fly Loft Framing

The primary roof framing consists of one heavy timber truss spanning the length of the fly loft supporting built-up 7 ½" x 2" (3&4 ply) rough sawn beams spaced at 14' o.c. The secondary roof framing consists of 2x6 rafters at 24" o.c. with 1x8 straight sheathing (*Figure 5.1*). We performed several cores through the roof layers and discovered that

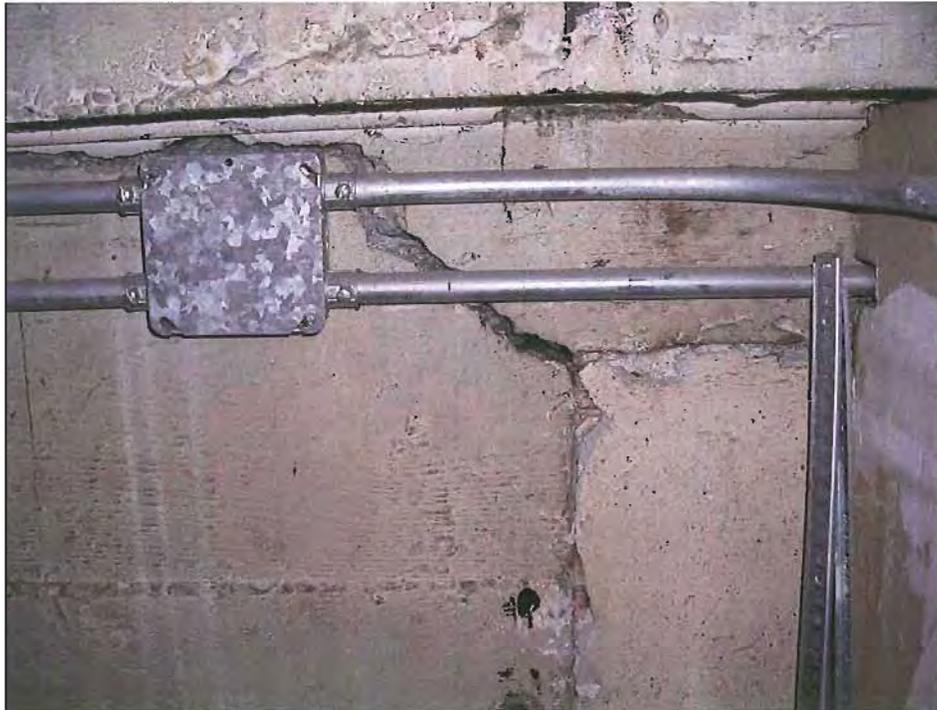
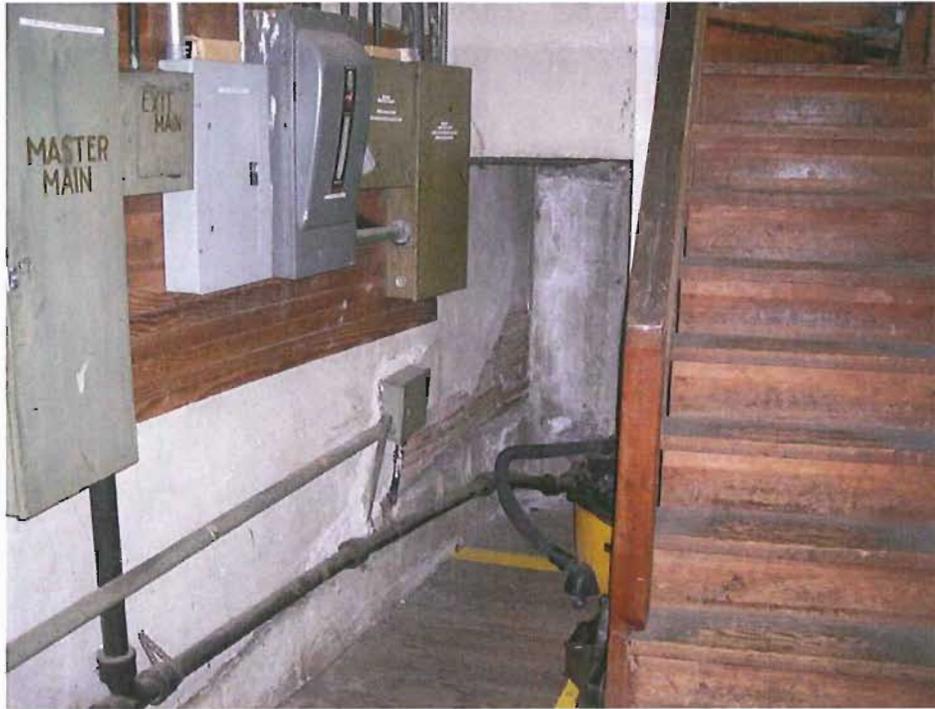
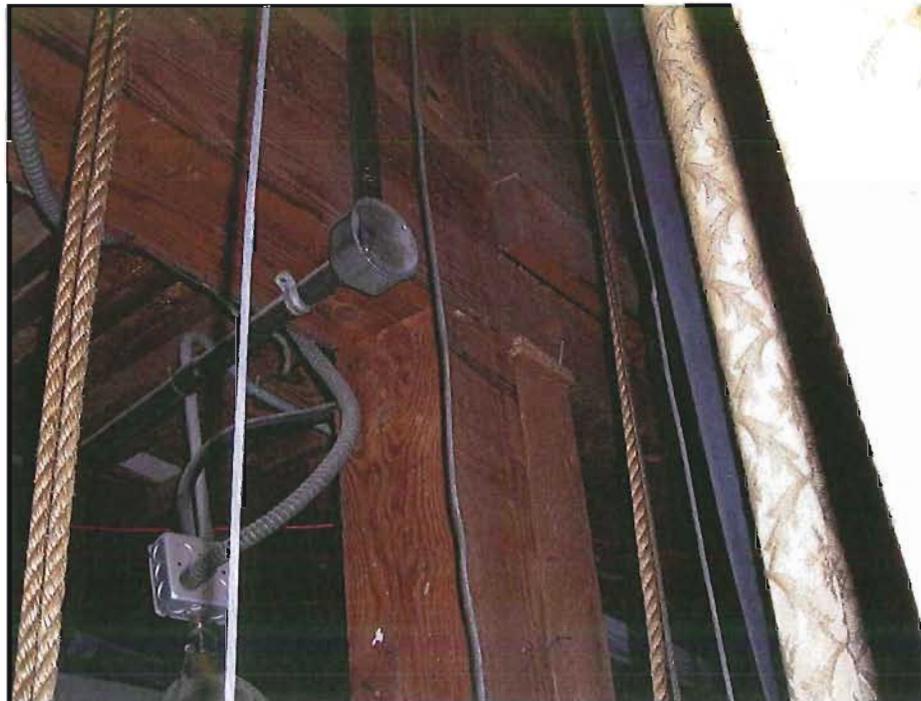
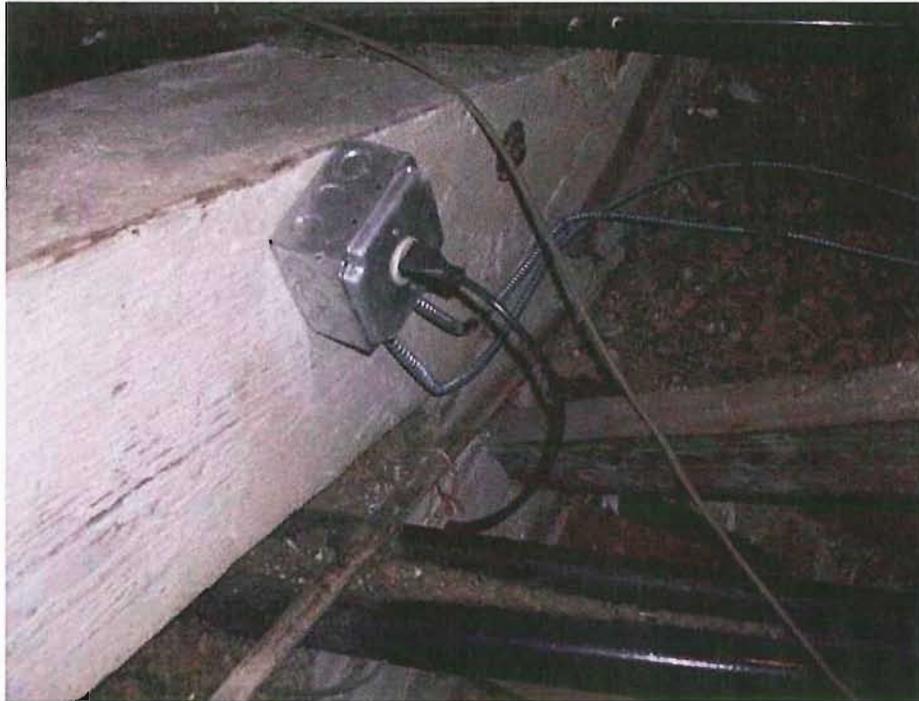
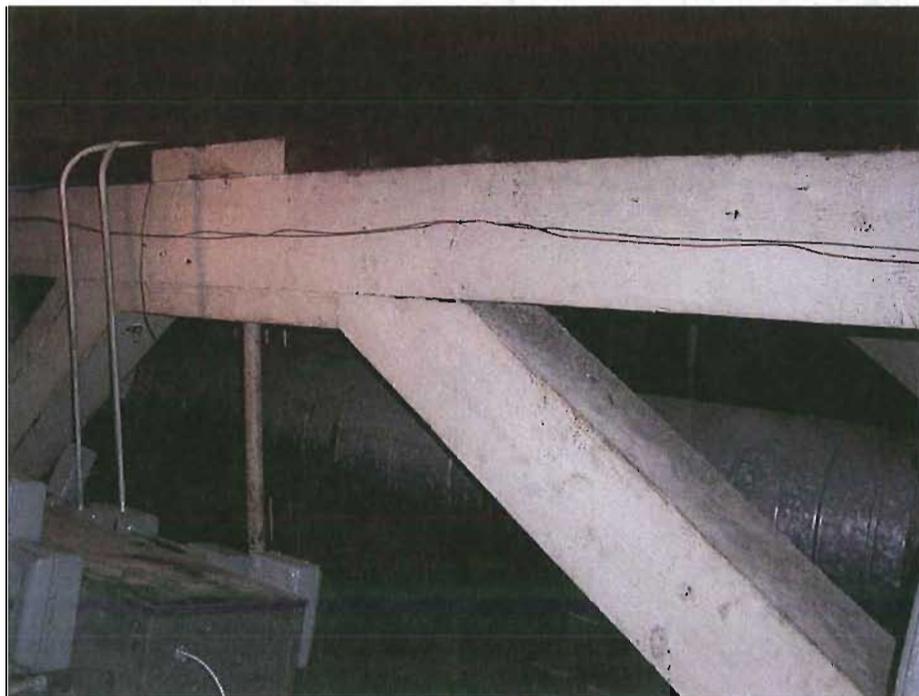
Figure 6.1 – Electrical System

The existing electrical system in the theatre has been modified and added to several times over the years. Much of the work is undocumented and appears to be difficult to evaluate (Figure 6.1). However, according to Cedar Electric, who had recently worked in the building, the following is a summary of the current condition:

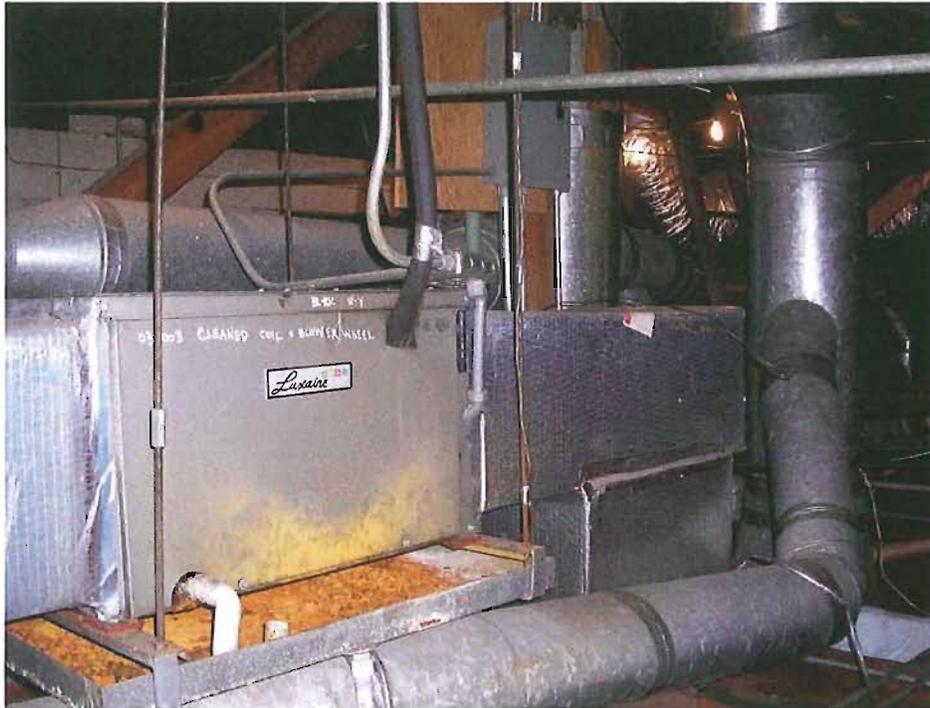
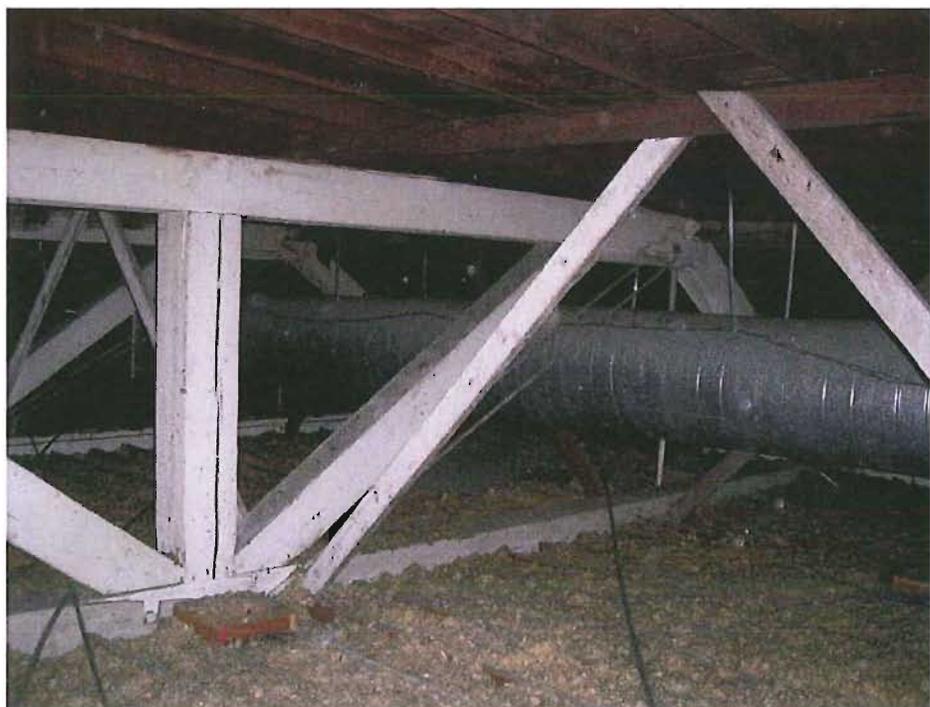
Figure 6.2 – Mechanical System

It is our understanding the heating system in the building was recently upgraded from an oil furnace boiler system to a gas fired heating system. The remaining furnace and supporting structure will be removed during the reconstruction of the fly loft. The existing gas unit will need to be removed to allow room for the new construction of the fly loft, and put back in its original location. At this time no upgrade of the mechanical systems has been identified to complete this task and continue operations. The large diameter duct in the attic that feeds the rear of the theatre will be braced against seismic forces (*Figure 6.2*). This work has been included in the project budget for this phase and should have a minimal impact.

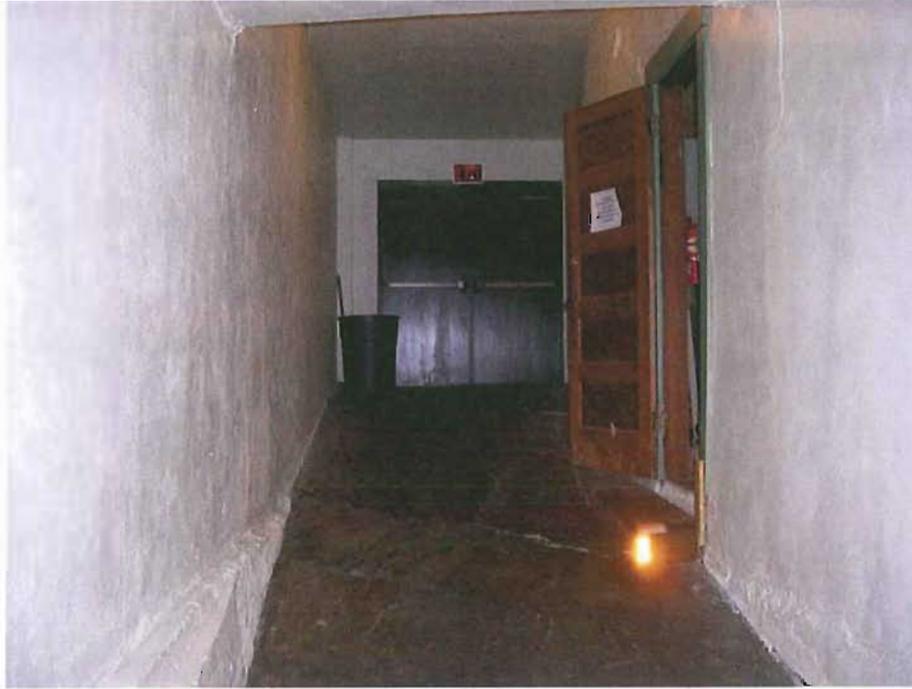
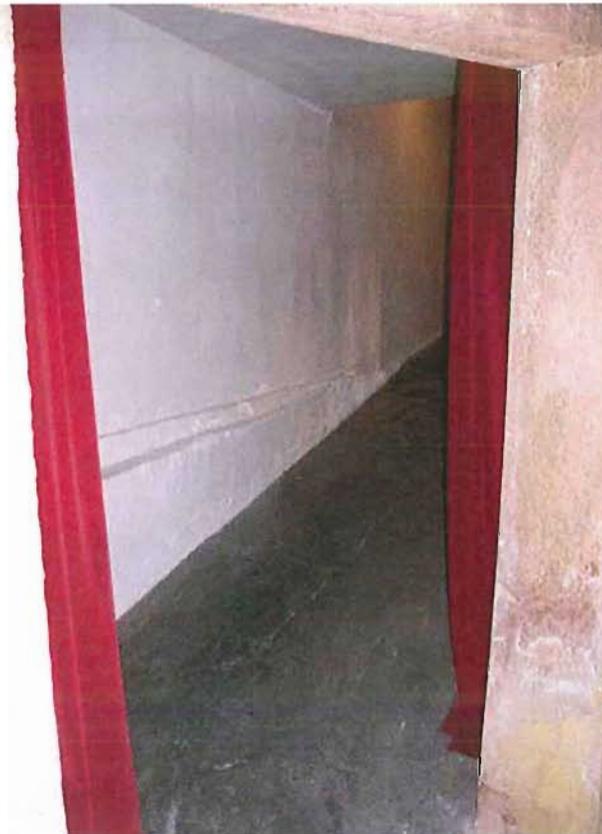
Figure 6.3 – Rear Exit

It is the intent of the project to provide a safe and efficient facility for both employees and patrons of the theatre. Due to the level of work performed and its historical status, it is not required to completely address all accessibility deficiencies (*Appendix B*). We have recommended selected areas to be addressed in phase one based on priority and limited impact to the historical value of the building. However, these improvements will not make the facility fully compliant to current ADA requirements. As discussed above, two unisex accessible restrooms will be constructed on the main level accessible from the lobby (*Sheet A1.1*). The front door will be replaced to provide proper hardware and thresholds. The rear exit doors will be upgraded with handrail on each side ramps and the ramps will be rebuilt to provide a uniform path of travel (*Figure 6.3*). Refer to '*Rehabilitation*' plans for additional information.

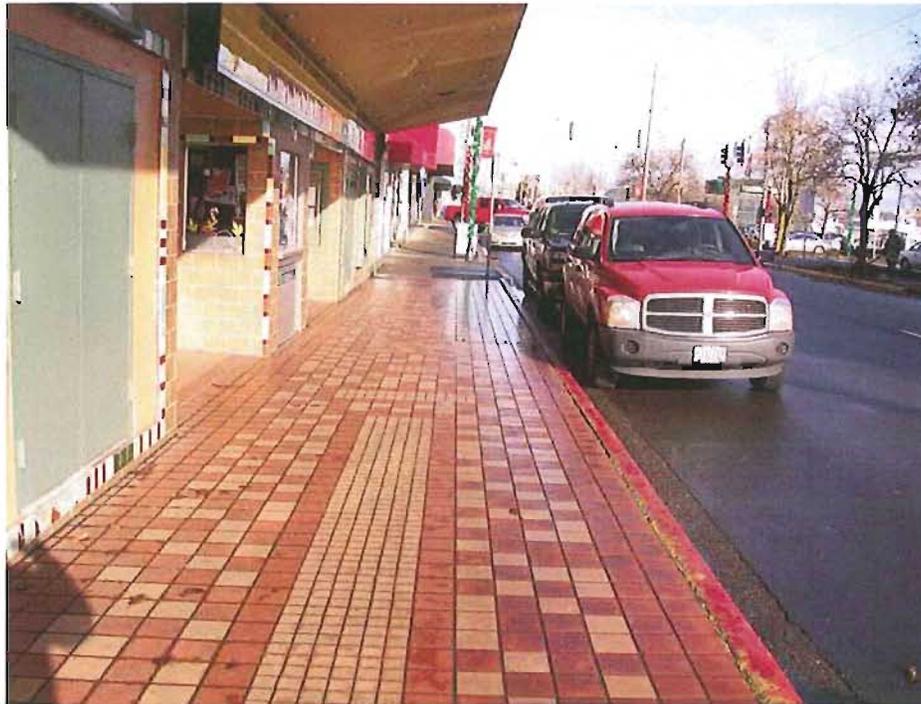
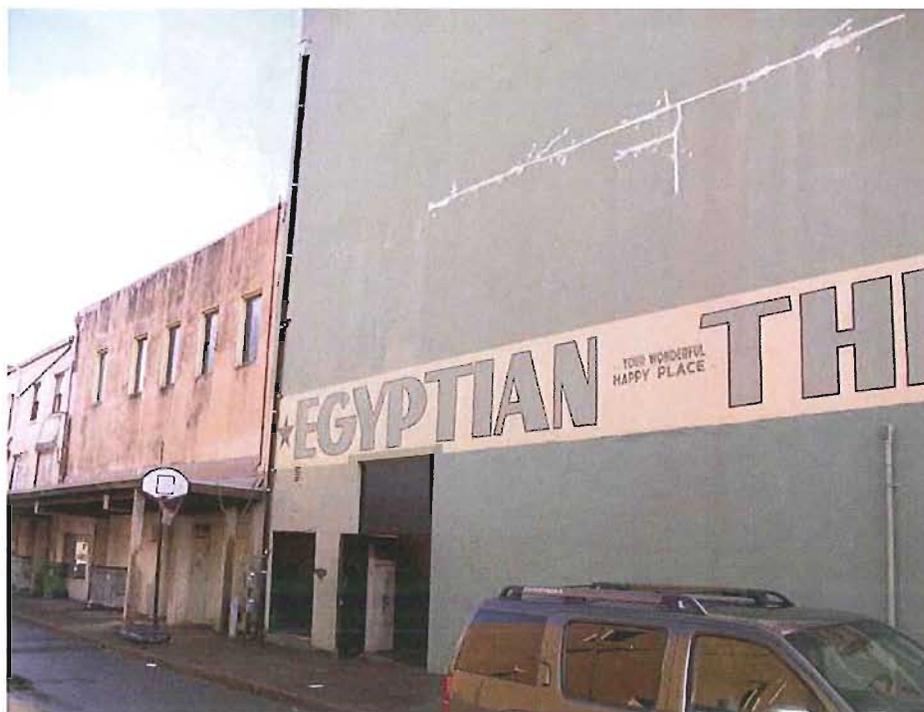
Figure 6.4 – Exterior Finishes

The exterior finishes facing the street will only be impacted as need to access the foundation and installing the water line for the sprinkler system. The concrete and tile sidewalk will need to be cut and removed and then replaced to match (*Figure 6.4*). The exterior finish at the rear fly loft wall will be all new smooth concrete finish similar to the original construction. The "EGYPTIAN THEATRE" mural on this wall will need to be repainted (*Figure 6.4*). It is our understanding the custom paint will need to be deferred to the second phase as it is not necessary to continue operations.

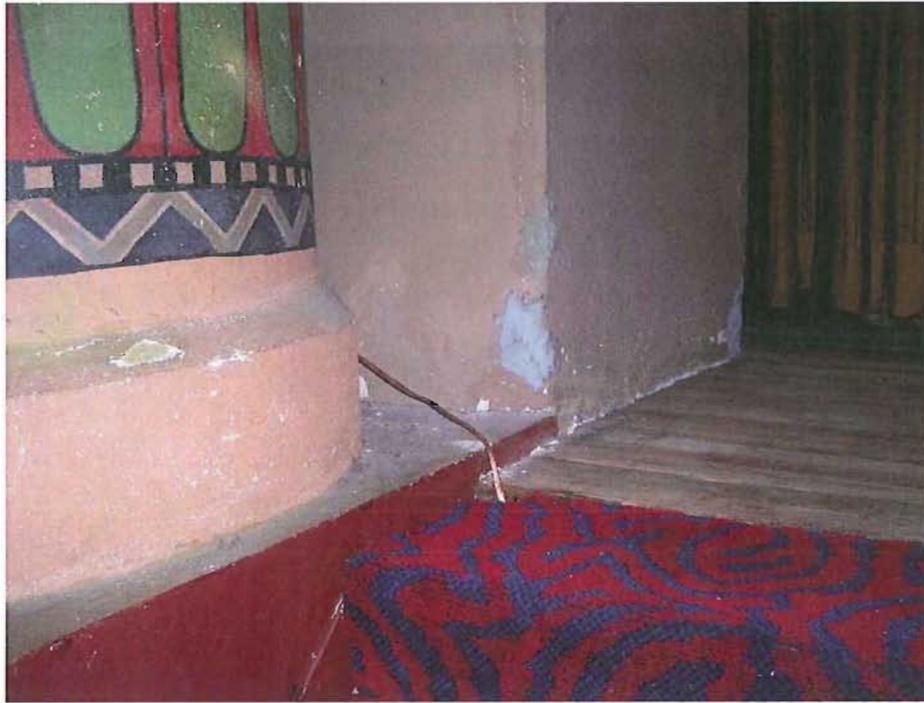
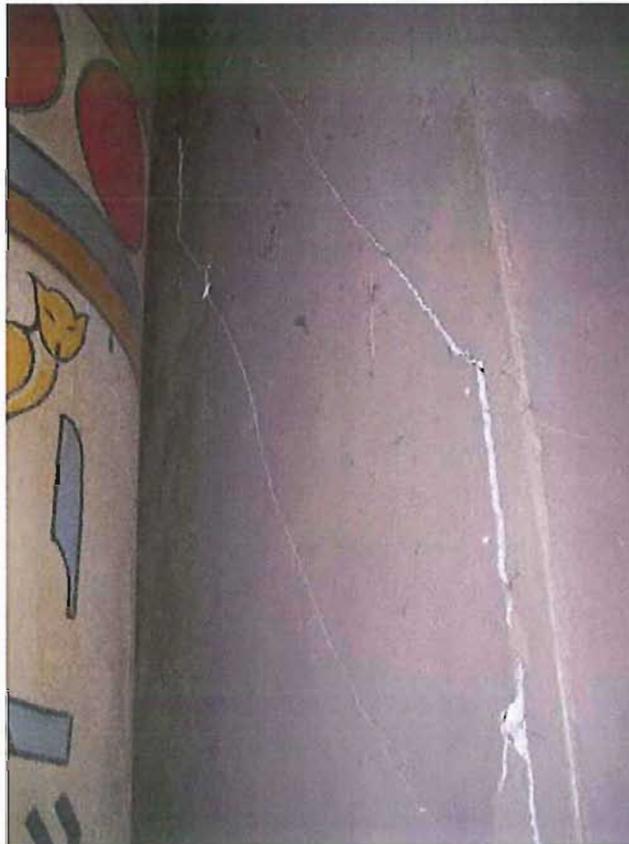
Figure 6.5 – Interior Finishes (Stage)

The interior finishes throughout the building are in disrepair, dirty, and have been modified to fit changing needs of the theatre owners (*Figure 6.5*). The proposed structural renovation work outlined above will further impact the finish of the original construction. Every possible step should be taken to preserve what is not necessary to remove to provide access for the renovation. The areas that must be removed will be replaced with gypsum sheathing, textured to match, and painted with a solid base paint most resembling the area impacted. Areas that have custom artwork will need to be deferred to the second phase as it not necessary to continue operations. Any decorative wood case work that is removed will need to be deferred as well. A complete interior finish restoration project should be completed all at once and will require a significant design and budget.
